# IN-SERVICE PERFORMANCE AND COSTS OF METHODS TO CONTROL URBAN RAIL SYSTEM NOISE

## SECOND TEST SERIES REPORT

INTERIM REPORT

U.S. DEPARTMENT OF TRANSPORTATION  
URBAN MASS TRANSPORTATION ADMINISTRATION  
Office of Technology Development and Deployment  
Office of Rail and Construction Technology  
Washington DC 20590

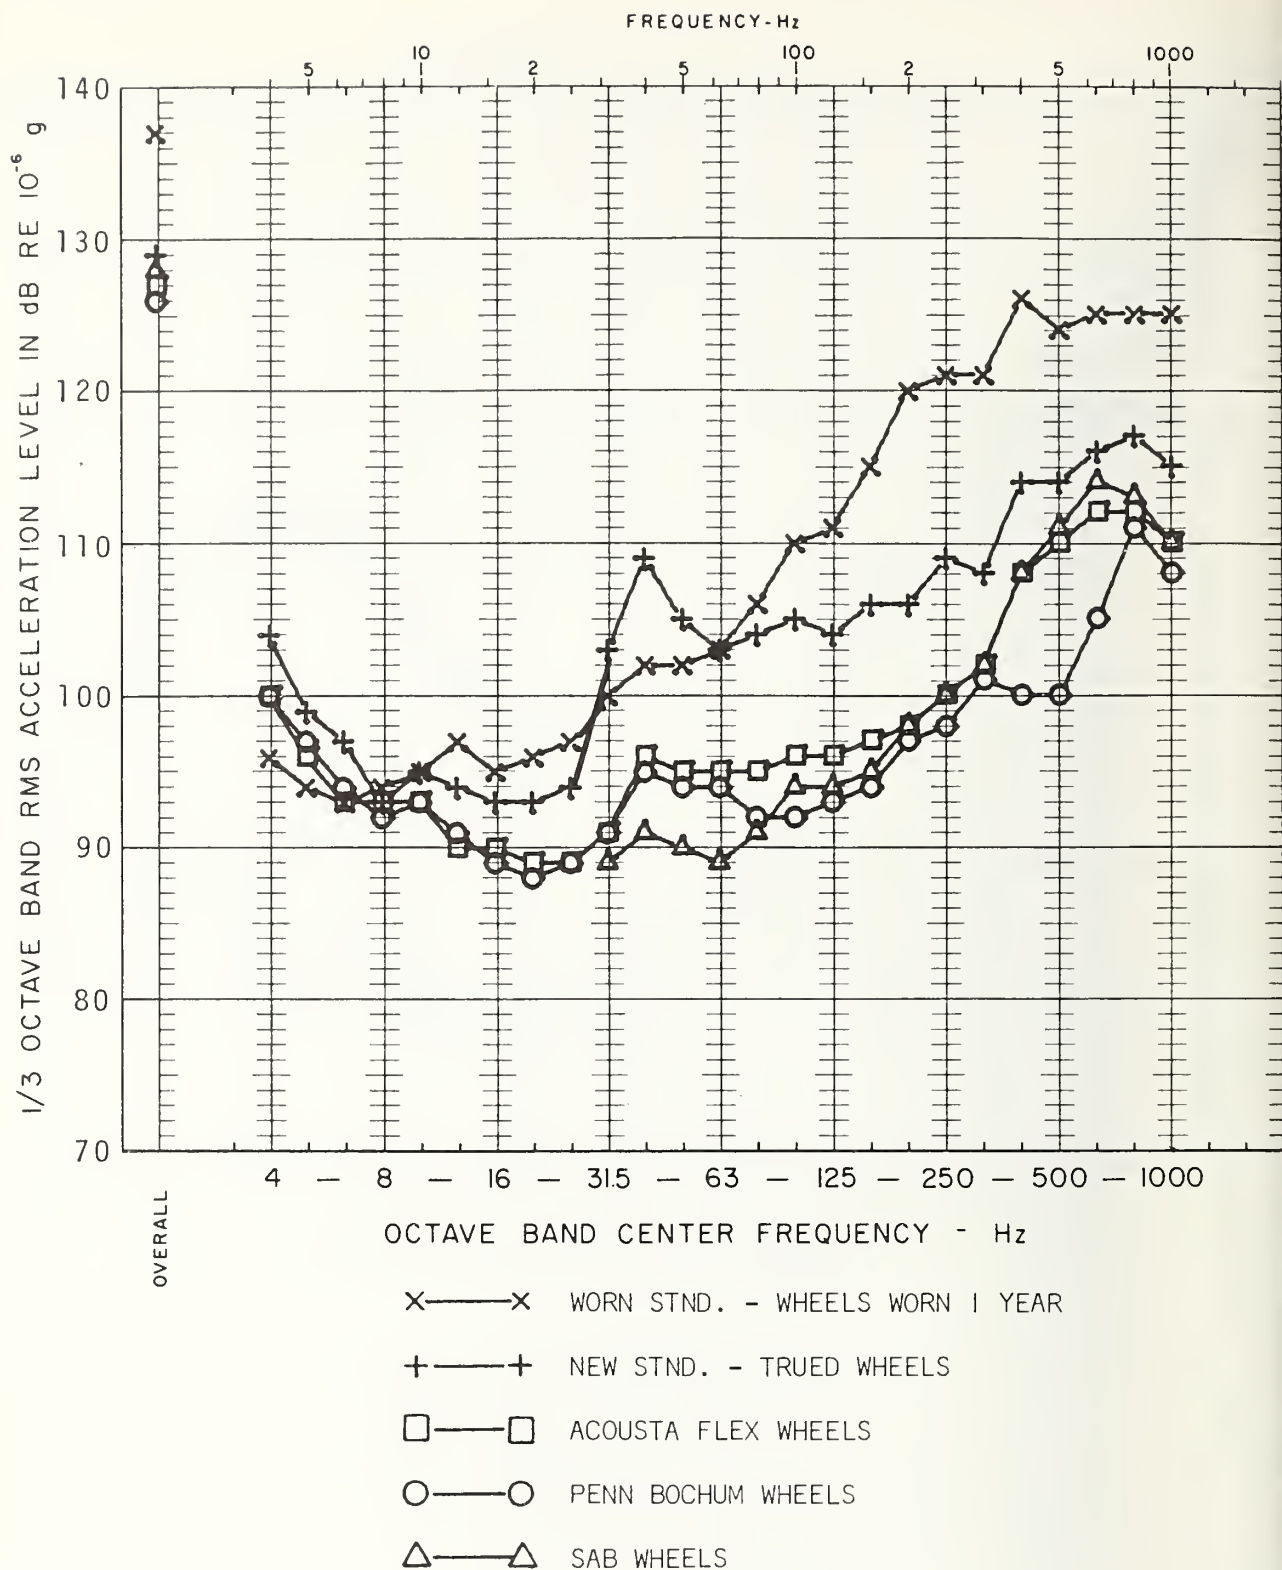
FIGURE 5-10. AVERAGE VERTICAL VIBRATION SPECTRA OF RAIL - SUBWAY TEST TRACK, TANGENT WELDED RAILS

PHASE IIB - GROUND RAILS

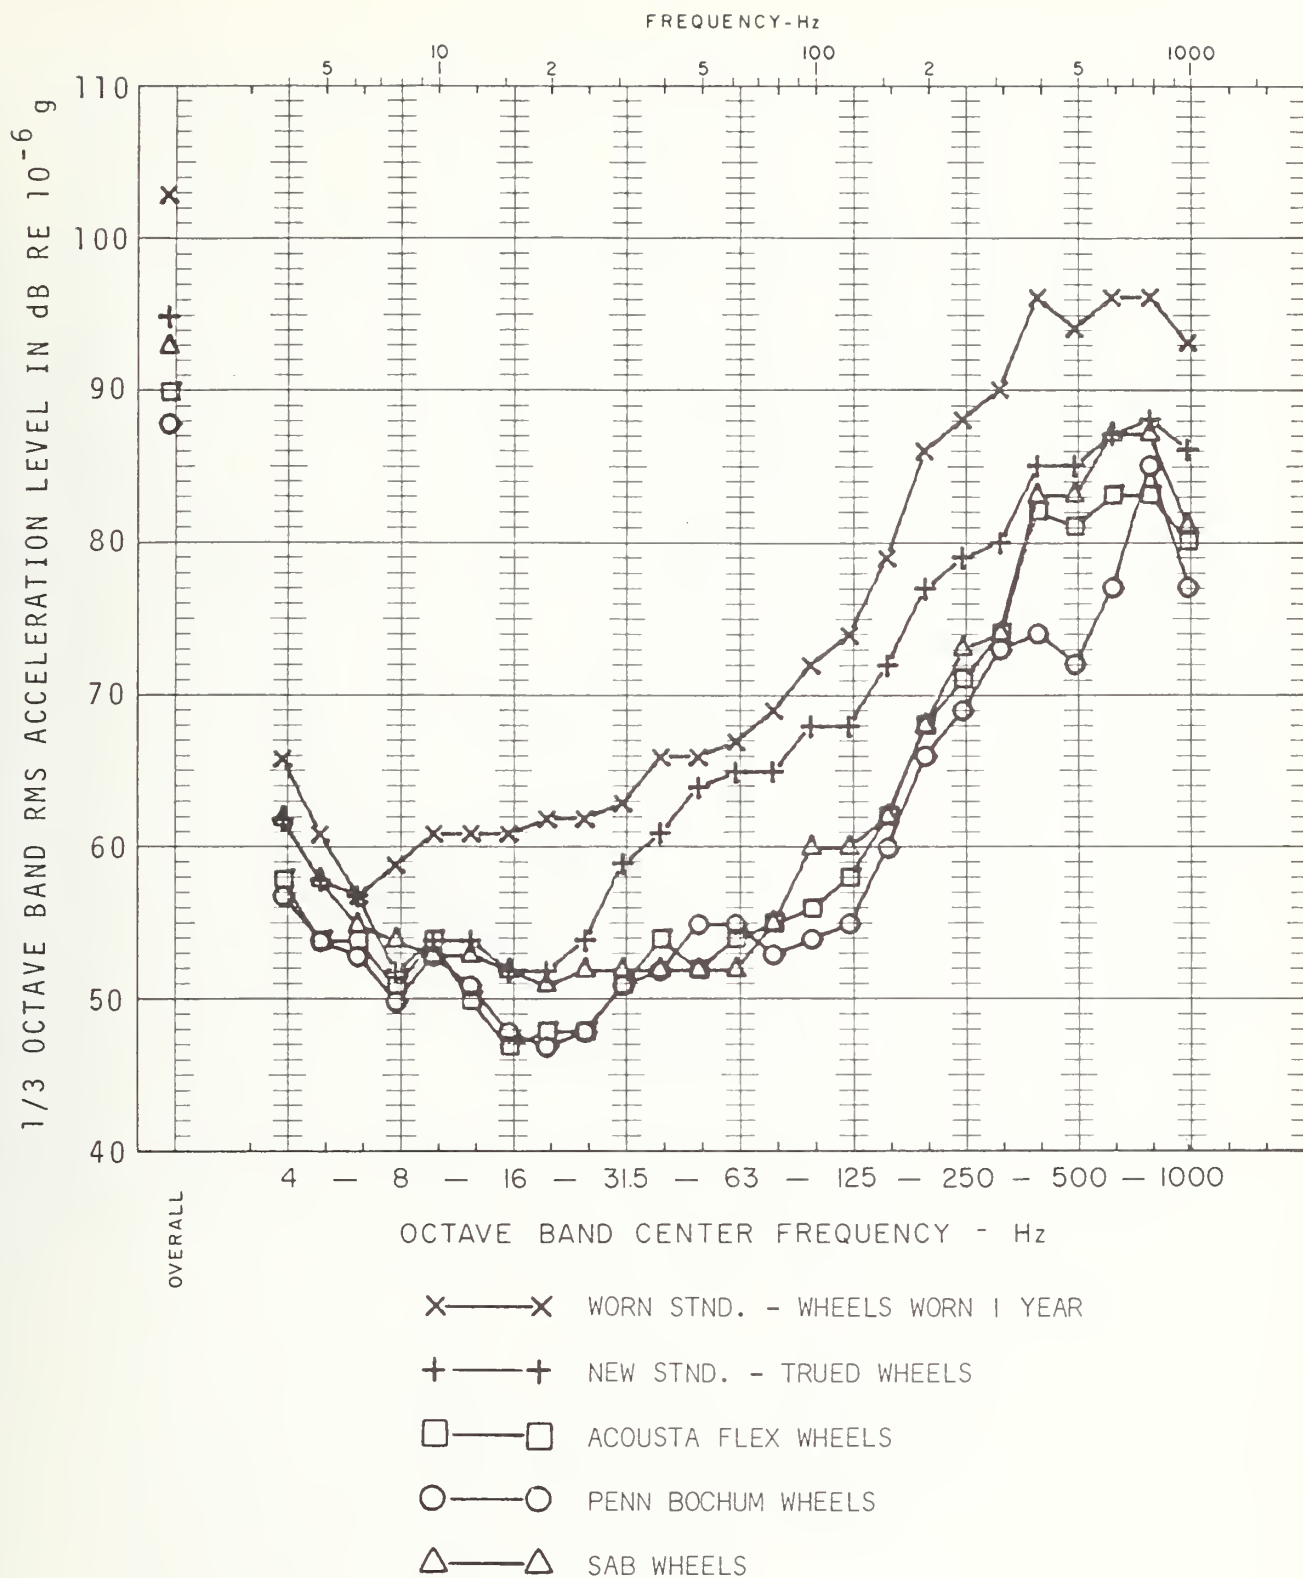
FIGURE 5-11. AVERAGE VERTICAL VIBRATION SPECTRA AT INVERT - SUBWAY TEST TRACK, TANGENT WELDED RAILS

PHASE IIB - GROUND RAILS

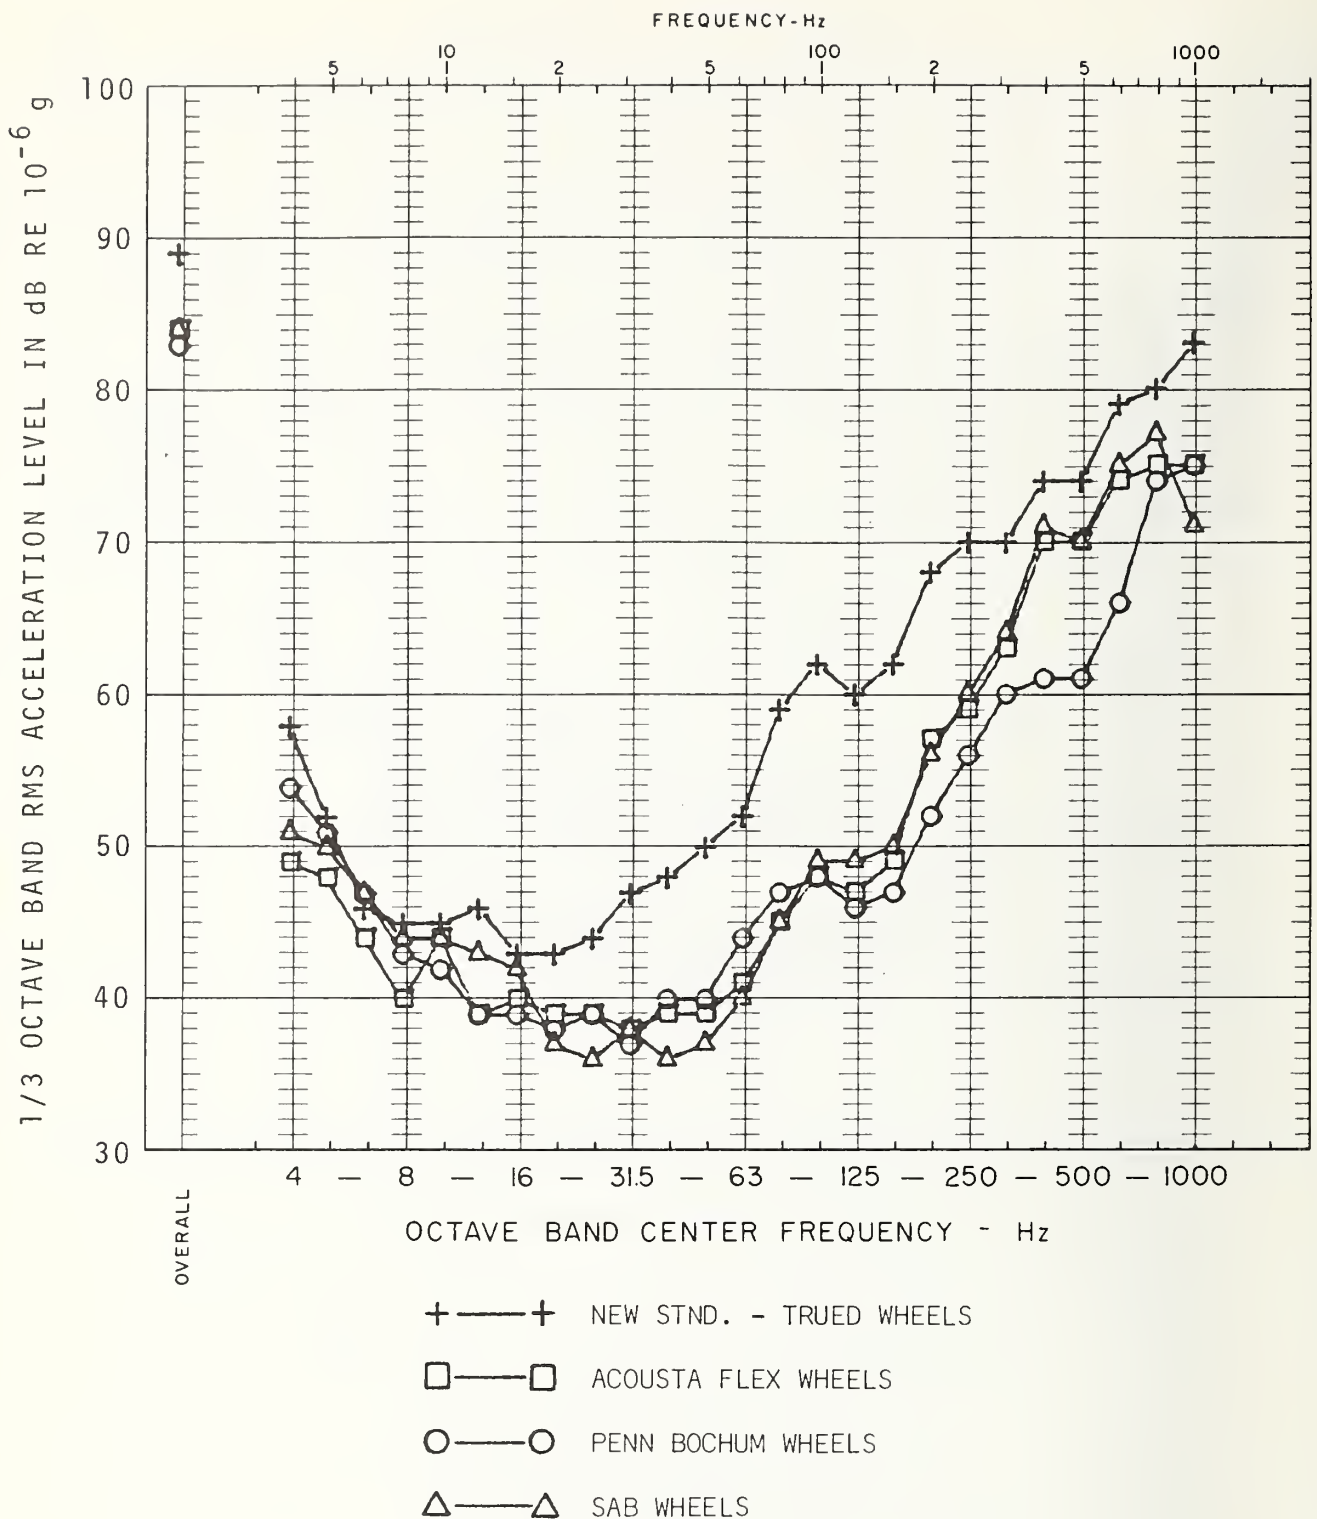
FIGURE 5-12. AVERAGE LATERAL VIBRATION SPECTRA AT INVERT - SUBWAY TEST TRACK, TANGENT WELDED RAILS

PHASE IIB - GROUND RAILS

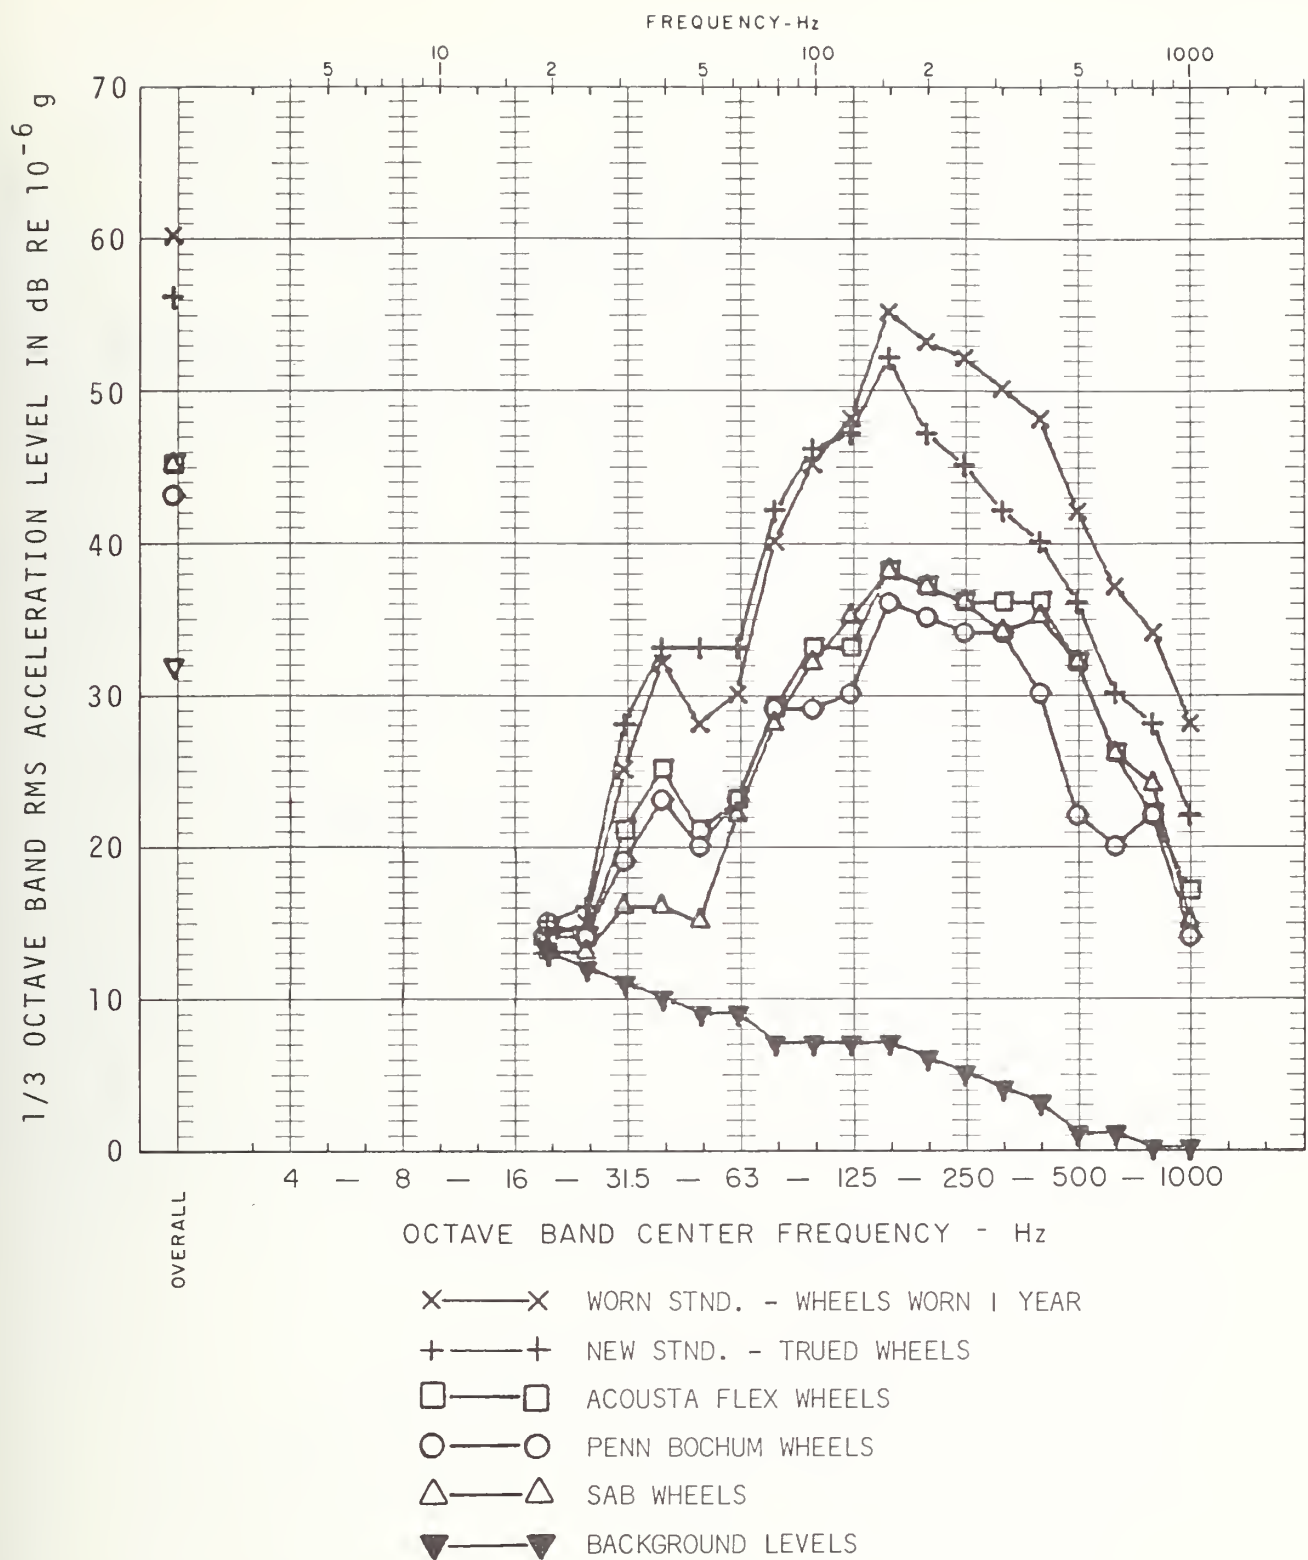
FIGURE 5-13. AVERAGE VERTICAL VIBRATION SPECTRA AT BASEMENT LOCATION - SUBWAY TEST TRACK, TANGENT WELDED RAIL

PHASE IIB - GROUND RAILS

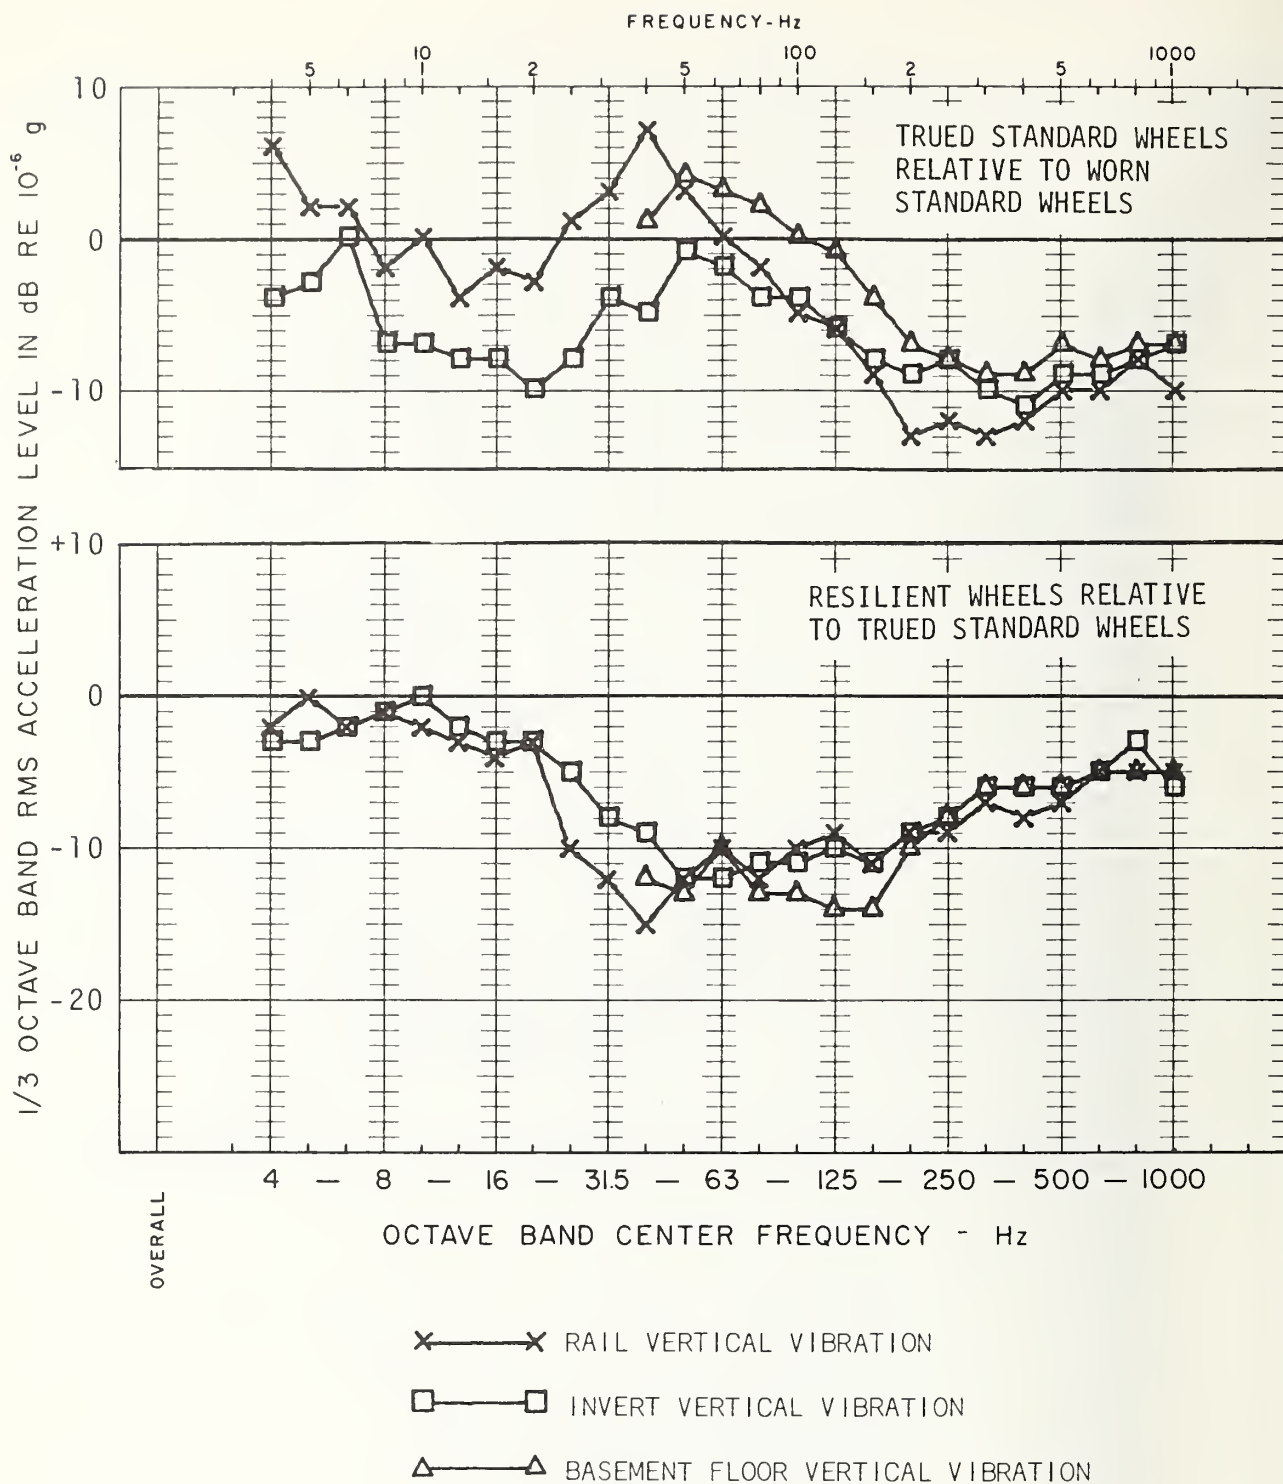
FIGURE 5-14 AVERAGE VIBRATION SPECTRA FOR TRUED STANDARD WHEELS  
RELATIVE TO WORN STANDARD WHEELS AND FOR NEW  
RESILIENT WHEELS RELATIVE TO TRUED STANDARD WHEELS -  
SUBWAY TEST TRACK, GROUND WELDED RAILS

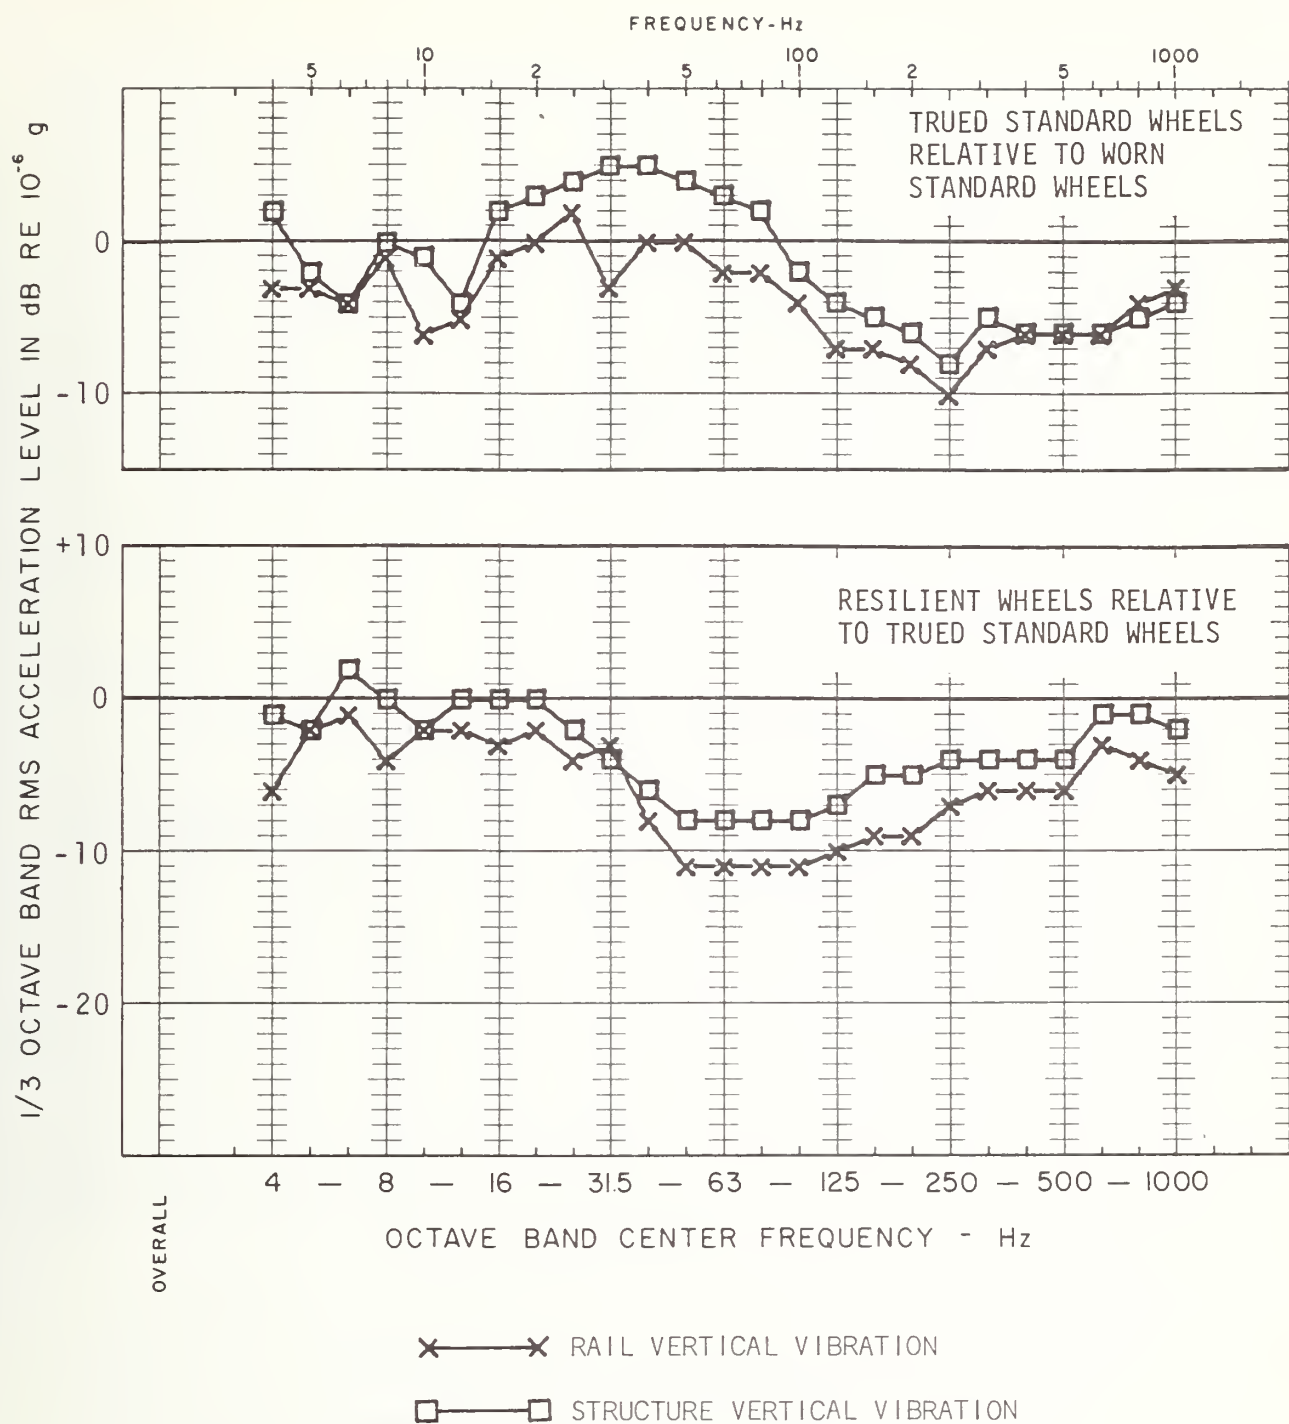
FIGURE 5-15 AVERAGE VIBRATION SPECTRA FOR TRUED STANDARD WHEELS  
RELATIVE TO WORN STANDARD WHEELS AND FOR NEW  
RESILIENT WHEELS RELATIVE TO TRUED STANDARD WHEELS -  
TW TEST TRACK, GROUND RAILS

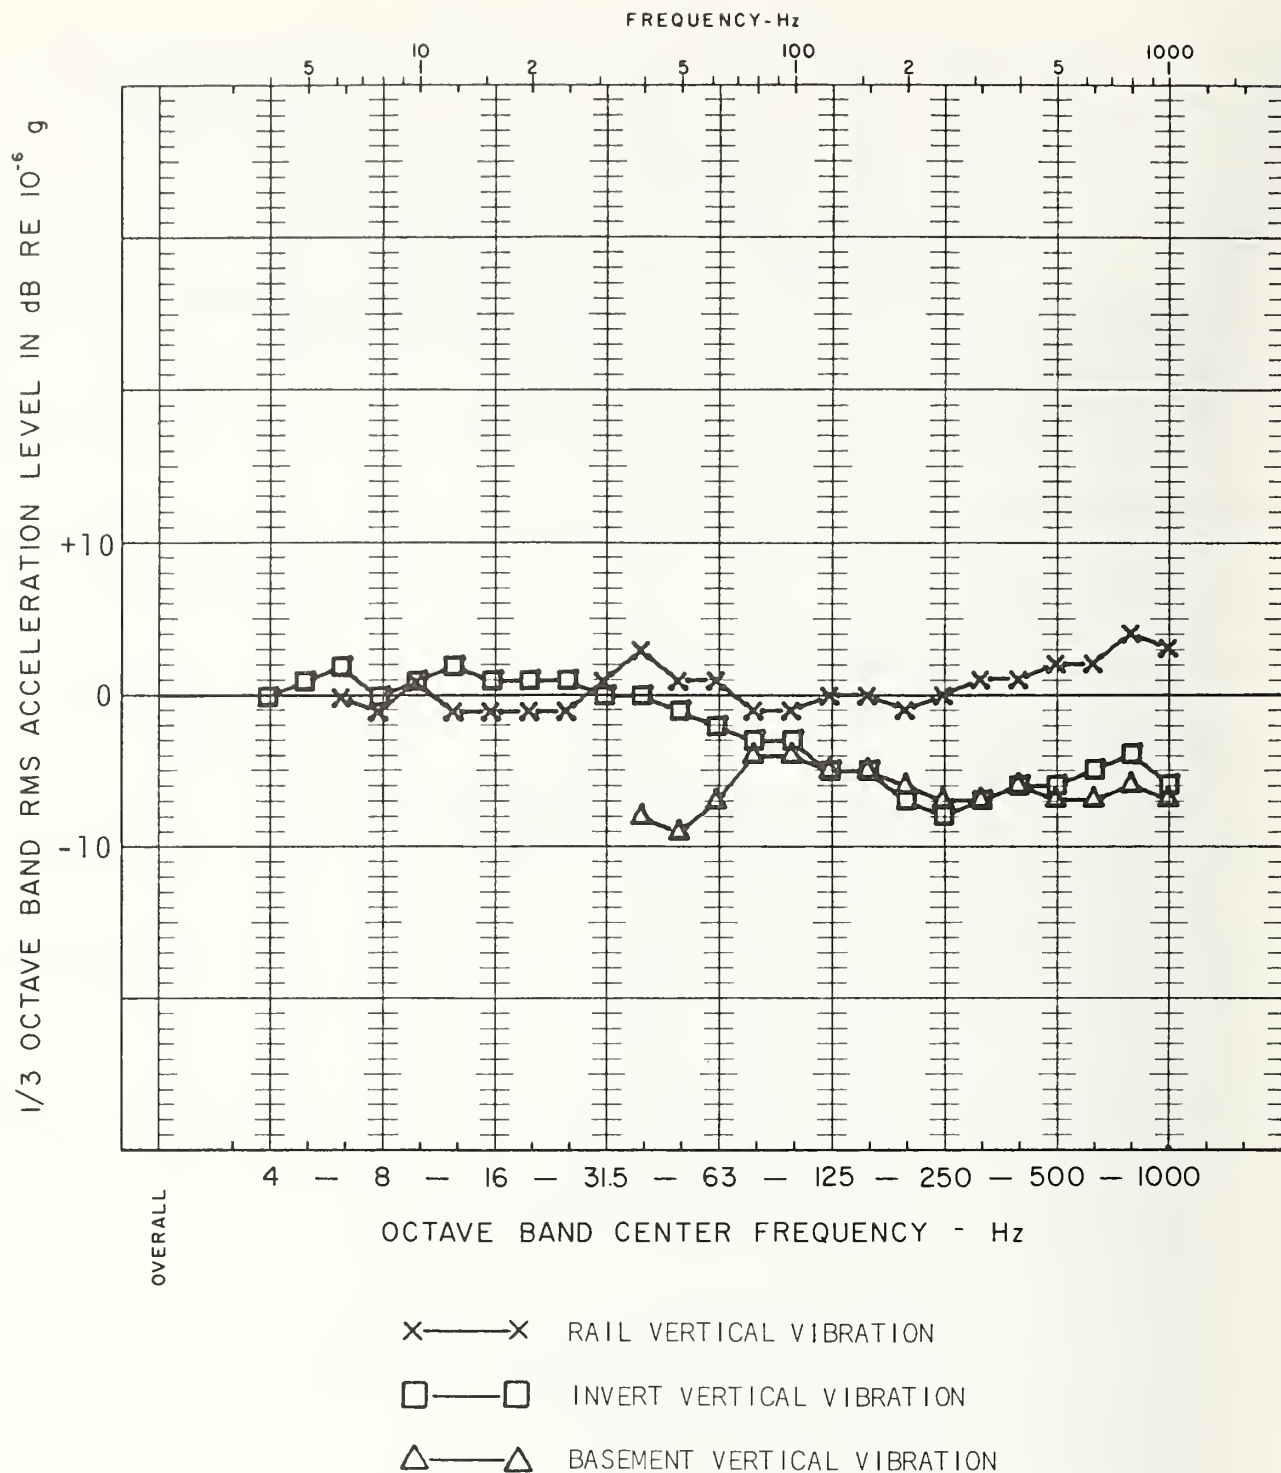
FIGURE 5-16. AVERAGE VIBRATION SPECTRA FOR RECENTLY GROUND RAILS  
RELATIVE TO WORN RAILS - SUBWAY TEST TRACK, TANGENT  
WELDED RAILS

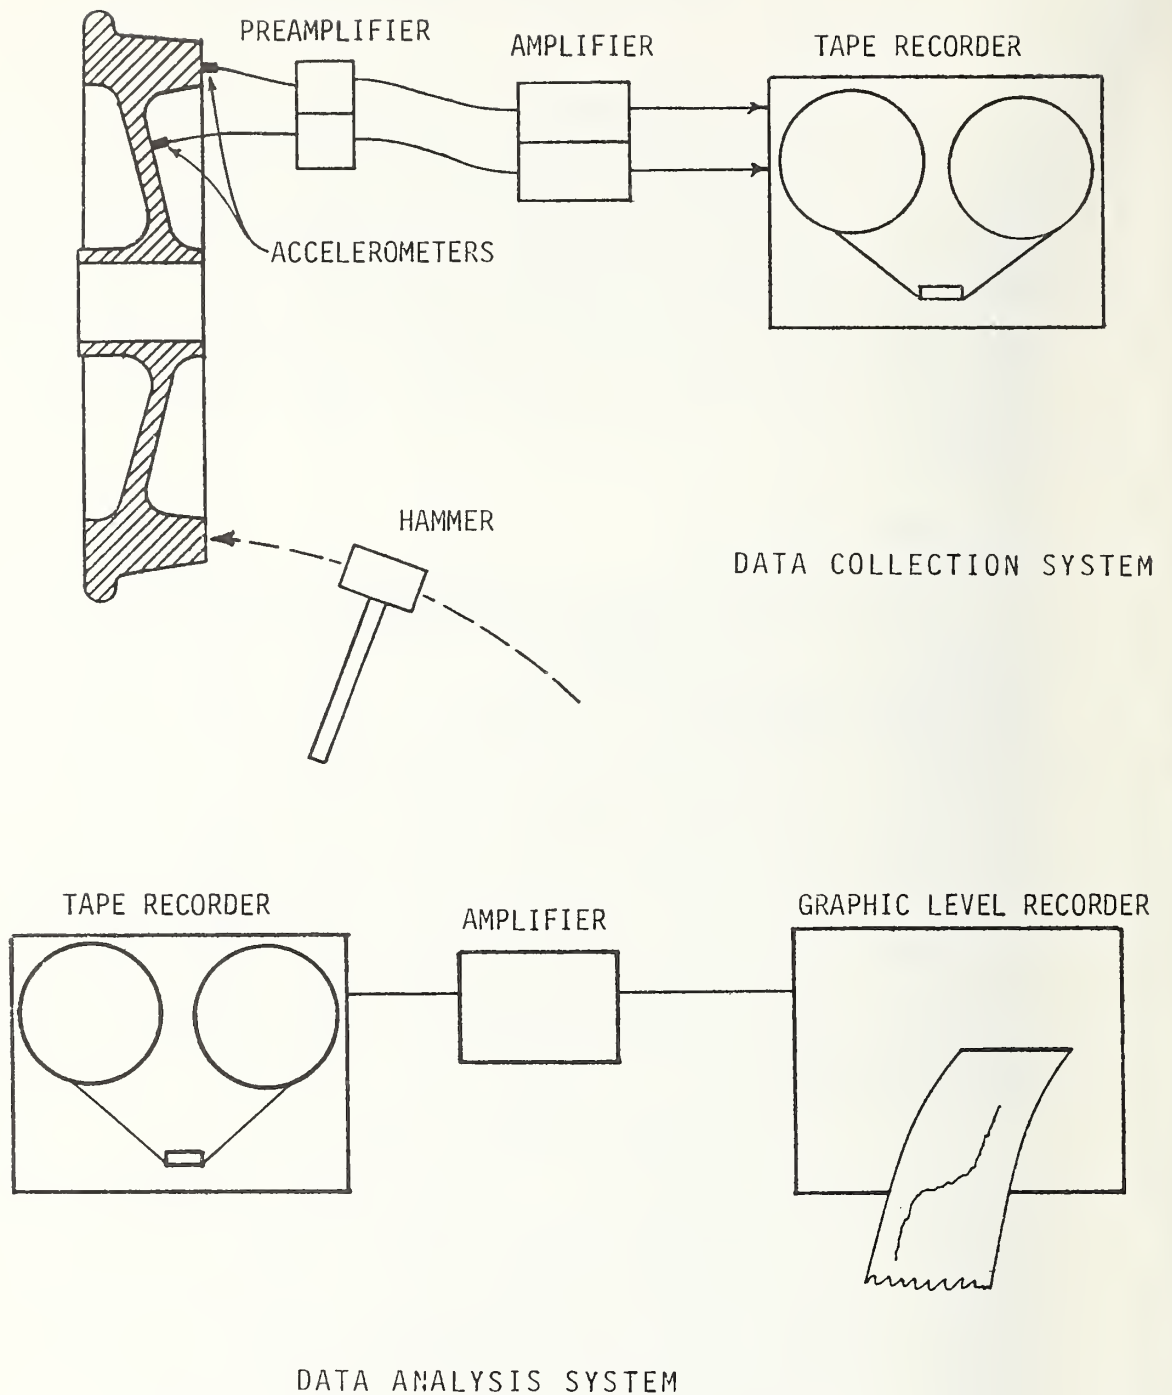
FIGURE 6-1. WHEEL VIBRATION DECAY MEASUREMENT SYSTEM

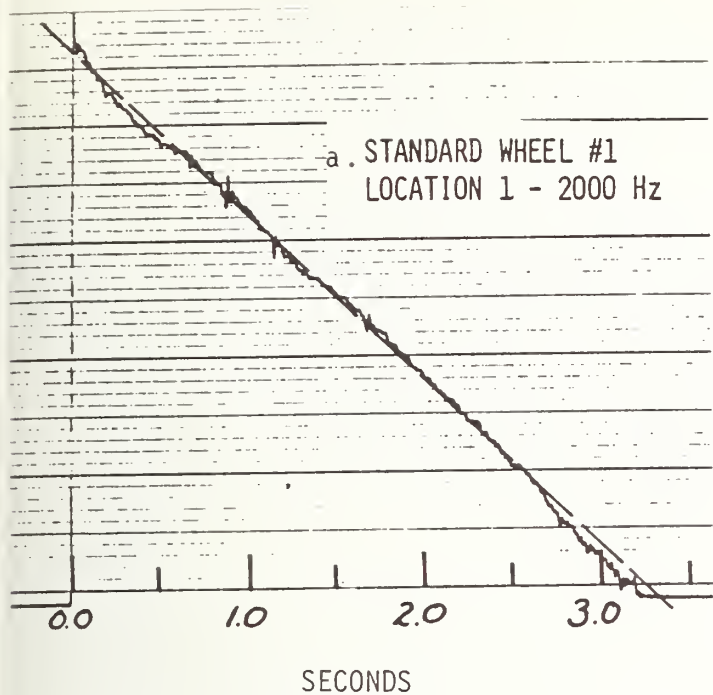
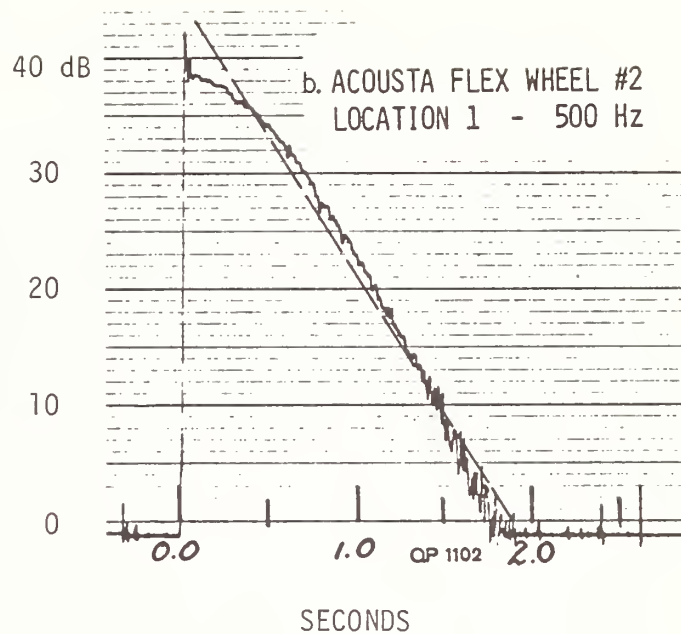
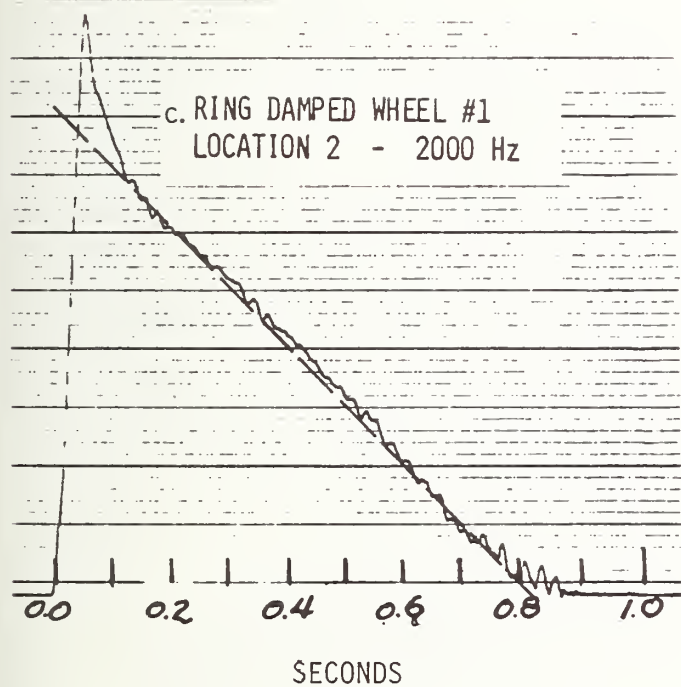
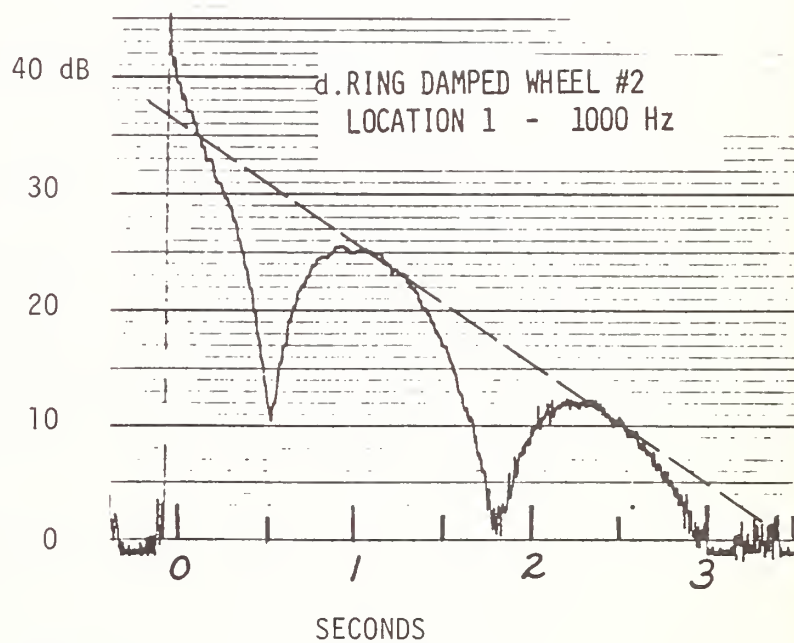
FIGURE 6-2 TYPICAL VIBRATION DECAY CURVES

Figure 6-2 presents some of the typical decay curves. In evaluating the loss factor, an effort was made to obtain the best fit straight lines for the decay curves. Examples such as Figure 6-2a are well represented by a straight line decay. Figures 6-2b, 6-2c and 6-2d are examples of decay curves requiring some subjective judgment in estimating the

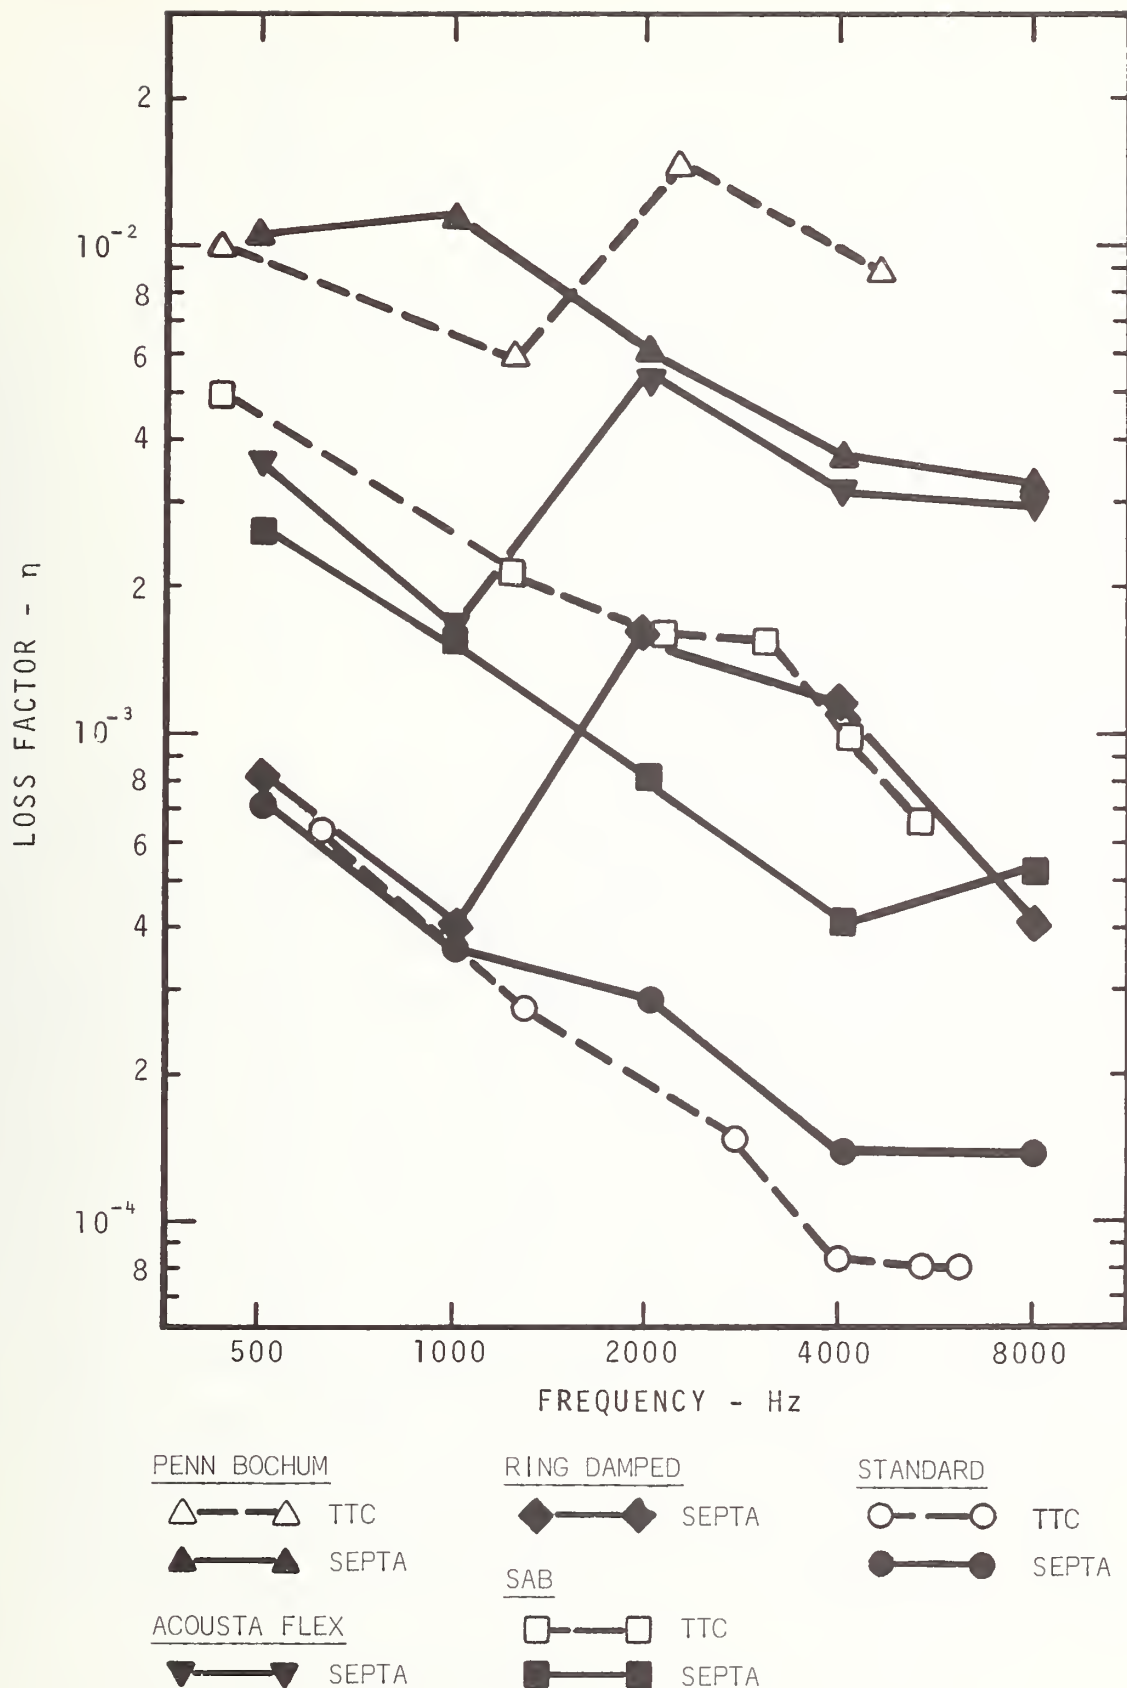
FIGURE 6-3. AVERAGE LOSS FACTORS FOR TEST WHEELS

Wheel Type	Frequency	Loss Factor ( $\eta \times 10^3$ )
Standard	620	0.64
	1580	0.28
	2750	0.15
	3990	0.084
	5280	0.082
	6250	0.082
Penn Bochum	434	10.2
	1240	6.2
	2200	16.6
	4600	9.6
SAB	433	4.8
	1190	2.2
	2100	1.7
	3070	1.6
	4090	1.0
	5160	0.78

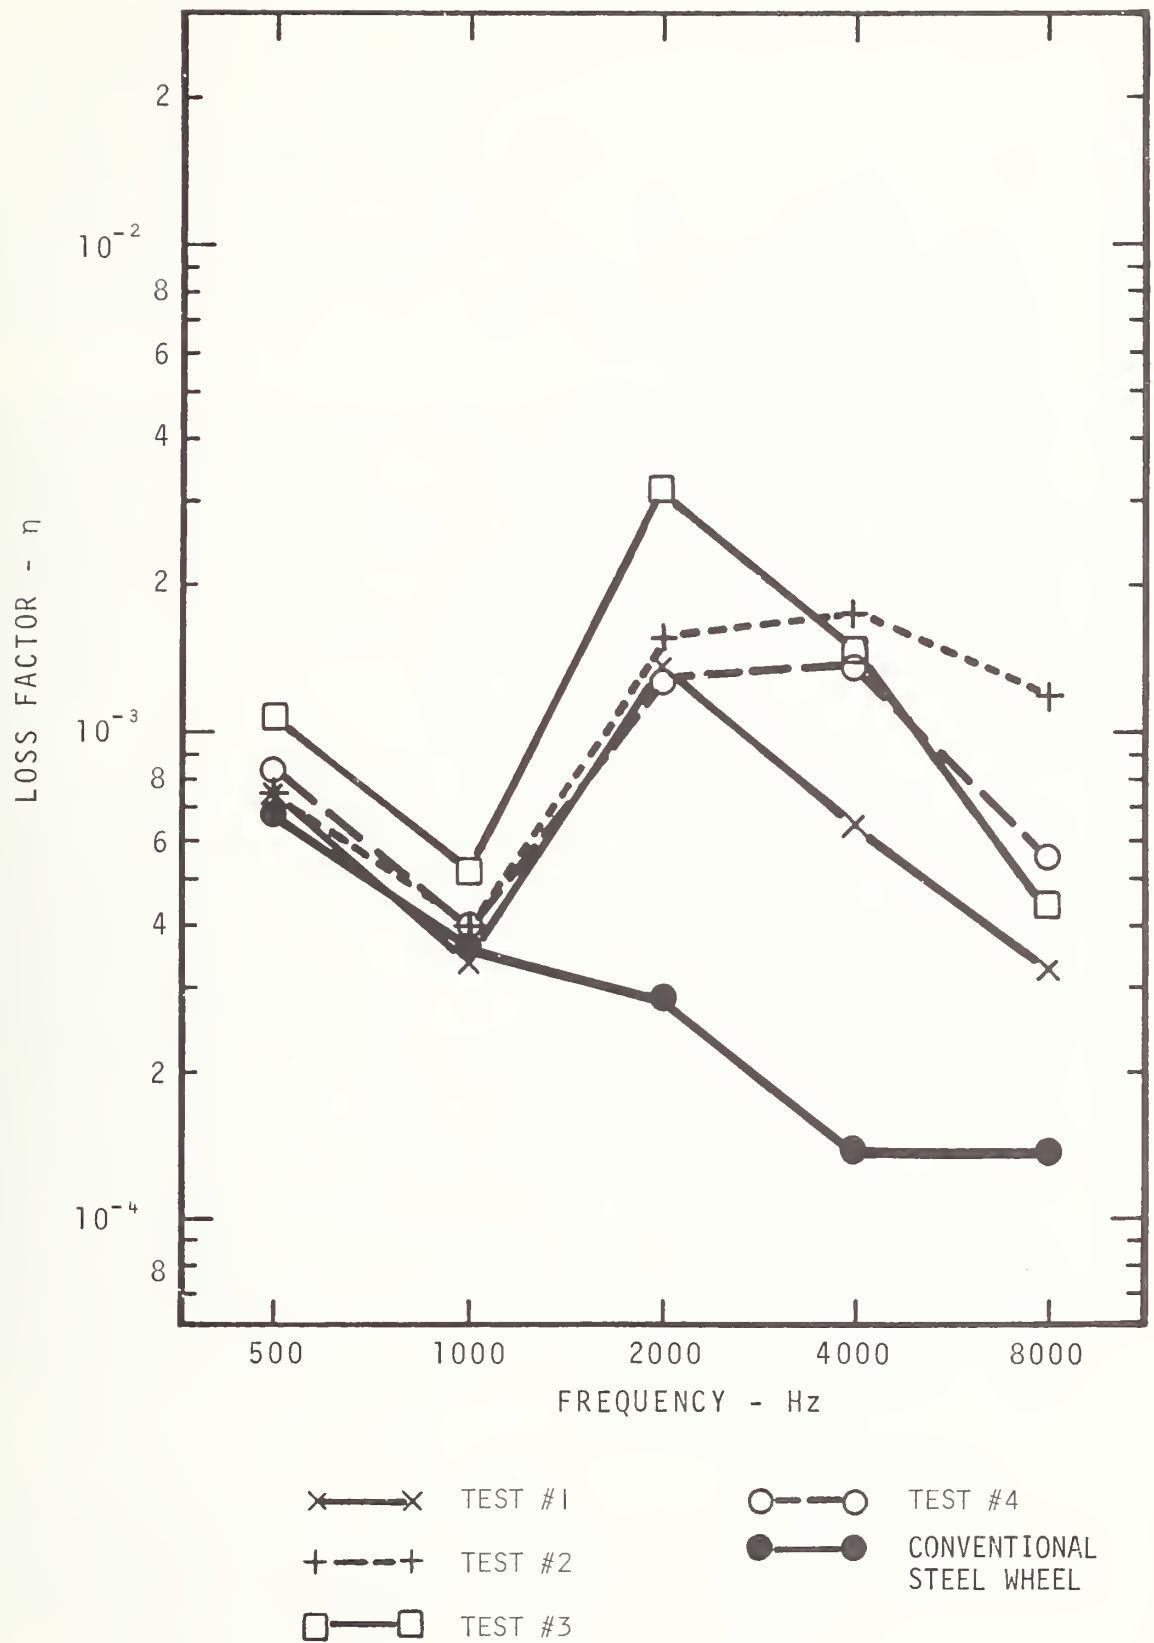
FIGURE 6-4. LOSS FACTORS FOR THE RING-DAMPED WHEELS

Figure 6-4 illustrates the results for the four tests with ring-damped wheels. In the 500 Hz and 1000 Hz octaves, the wheels have the same or only slightly greater damping than the undamped steel wheels. Above 1000 Hz the ring-damped wheels have 5 to 10 times the damping of the standard wheels. There is a considerable amount of loss factor variation with the four ring-damped wheels. It appears that small variations in the position of the damping ring in the groove can have a significant effect on the damping loss factors. This is indicated by the differences between the Ring-Damped #1 and Ring-Damped #2 Tests. These tests were performed on the same wheel with the ring removed and reinstalled between tests. The loss factors in the 4000 Hz and the 8000 Hz octave bands were more than three times greater for Ring-Damped #2 than for Ring-Damped #1. The difference can only be due to minor differences in the position and/or seating of the damping ring since all other test conditions were identical.
